## Radon resistant construction in Finland in 2007

Petteri Keränen

Project with H. Arvela, STUK

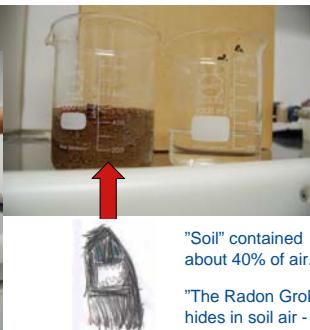
## Soil air

"Soil" contained about 40% of air.  
"The Radon Groke" hides in soil air - and streams with it.

Soil air streams in soil - like wind in a very dense forest.  
Comparison with water helps to understand its behaviour.
